# Service Technical Information

| MODEL NO. | TP-M920 |
| SUBJECT | Momentary erase occurs on opposite side of a tape |

REF.No. :G - 99 - 021 - E0

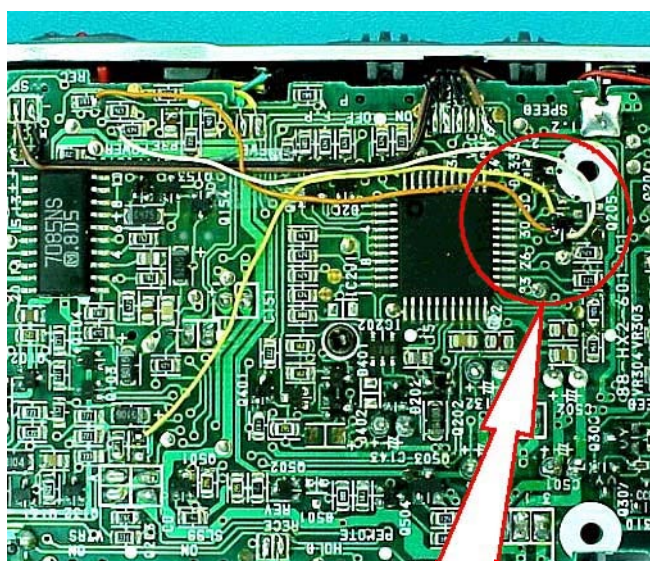
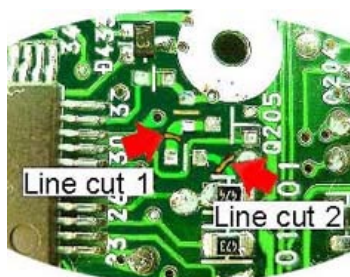
1) Cut the lines as indicated.

Add a transistor (RN2304) between 42nd pin of IC201 (MSM6576) and REC+B.

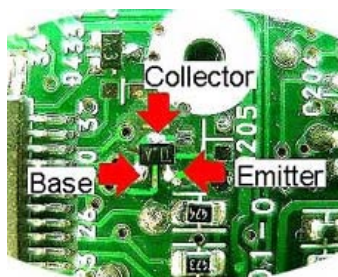
2) Solder the transistor (RN2304).

3) To solder wires to pins of the transistor.  
(Length of wires is all 5.5cm.)

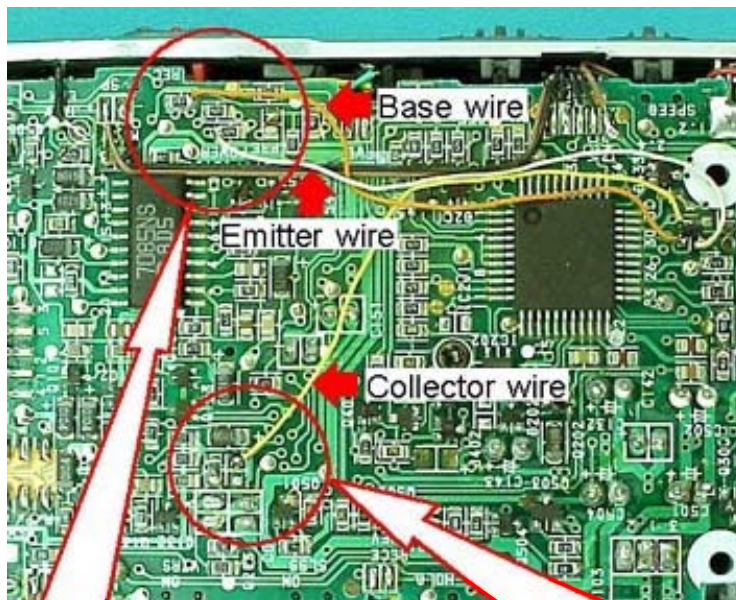
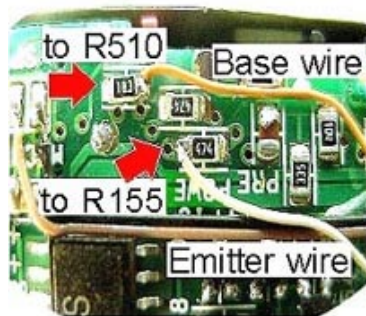
4) Solder base and emitter wires.  
Base wire: To R510  
Emitter wire: To R155

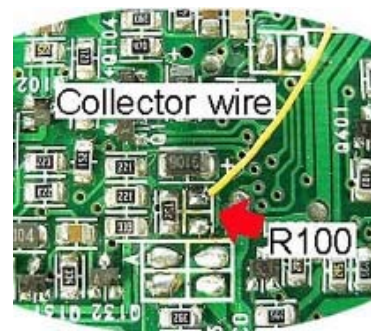
5) Remove R100 (22 Ohm),  
and to solder collector wire.
